## Old Sneddon Street Paisley **Network Rail Business Space Arch inspection Occupied Property**

Commercial Property Maintenance Services Ltd

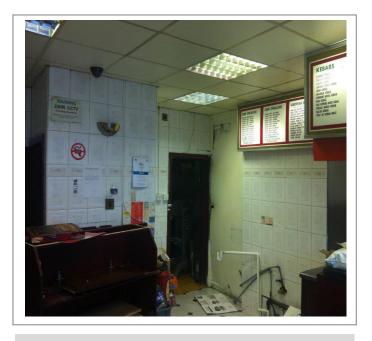
Property before work commenced.

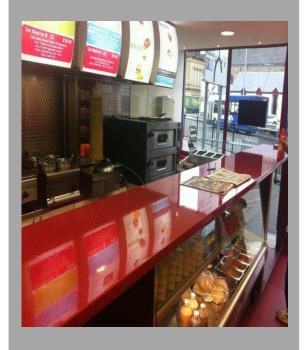
Front counter area after hand-back.
