**Baillieston Station  
First Scotrail  
Reactive Maintenance Works**

## **STAIR TREADS REPAIR AND RENEWAL**

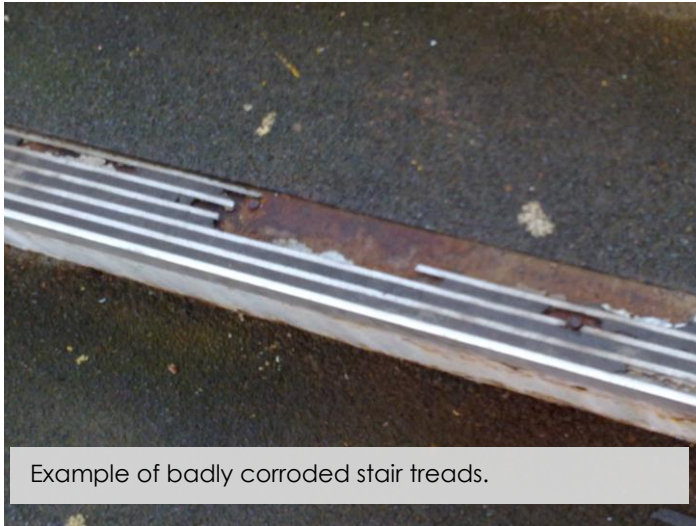
Example of badly corroded stair treads.

As part of the First Scotrail Reactive Maintenance Works, CPMS were asked to attend Baillieston Station and carry out repairs to the footbridge stair treads which were badly corroded.

- Safe removal and disposal of corroded stair treads.
- Installation of new replacement stair treads.
- Clean up and re-fixing of the remainder of stair treads.
- Work completed on time and budget, with no issues.

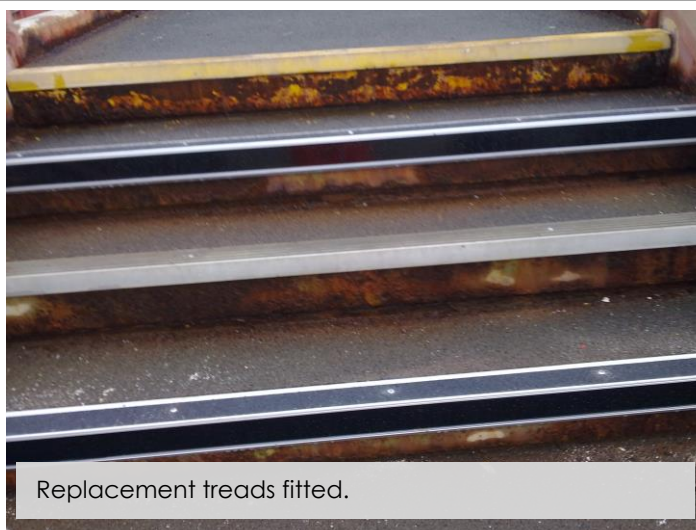
Replacement treads fitted.
