Lineside drainage Network Rail Grantshouse, Scottish Borders.

Commercial Property Maintenance Services Ltd

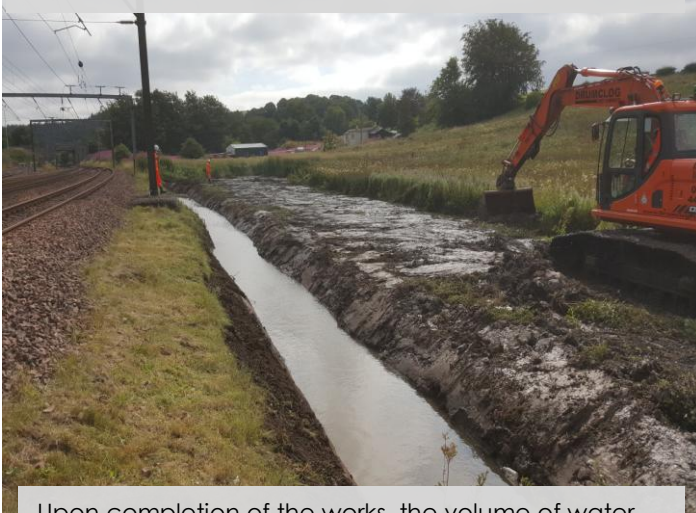
Excavated material was deposited on the lineside, graded and compacted to leave a level safe site.

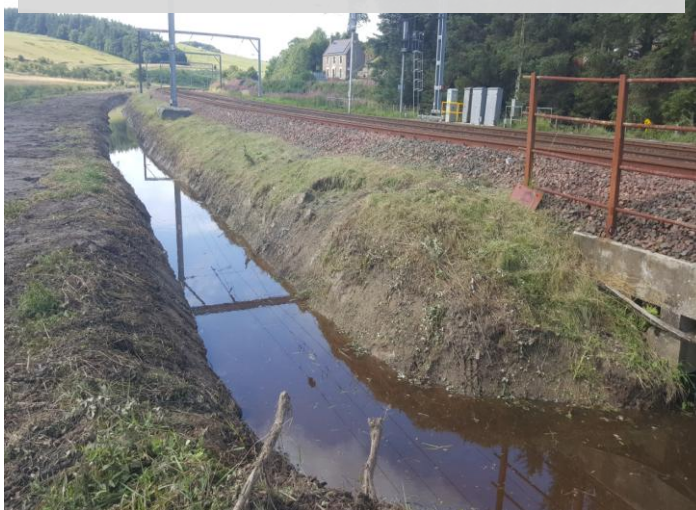
Upon completion of the works, the volume of water draining from the site had dramatically increased.
