Balustrade Repairs Network Rail Station Improvement

BALUSRADE REPLACEMENT

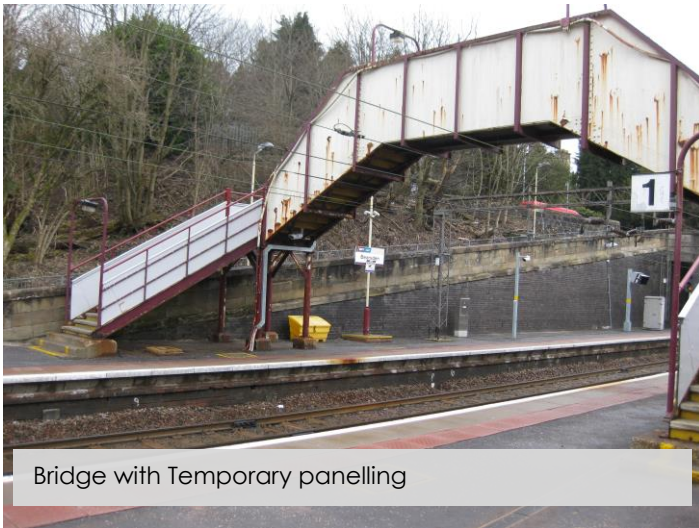
Bridge with Temporary panelling

- Initially install temporary timber panelling to similar bridges to eliminate the threat of this problem
- Arrange for a specification to be drawn up and approved to replace the balustrading.
- Fabricate and install new compliant galvanised balustrading complete with DDA hand -railing.
- Arrange suitable station and track access as required to complete the works.
- Works completed to time and budget.

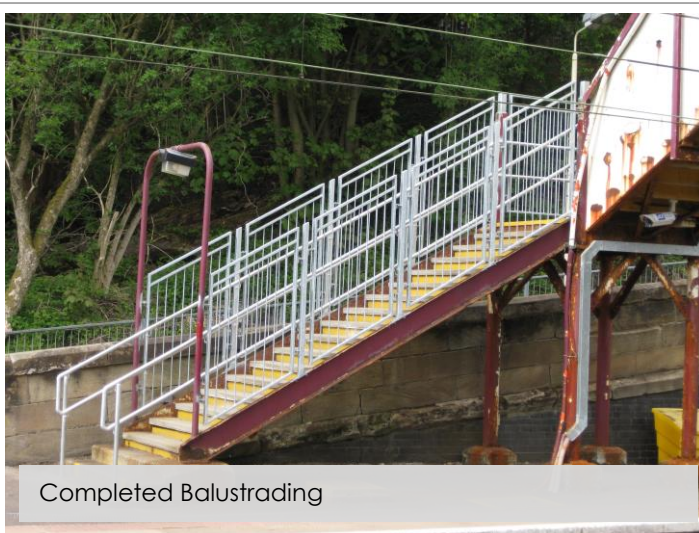
Completed Balustrading

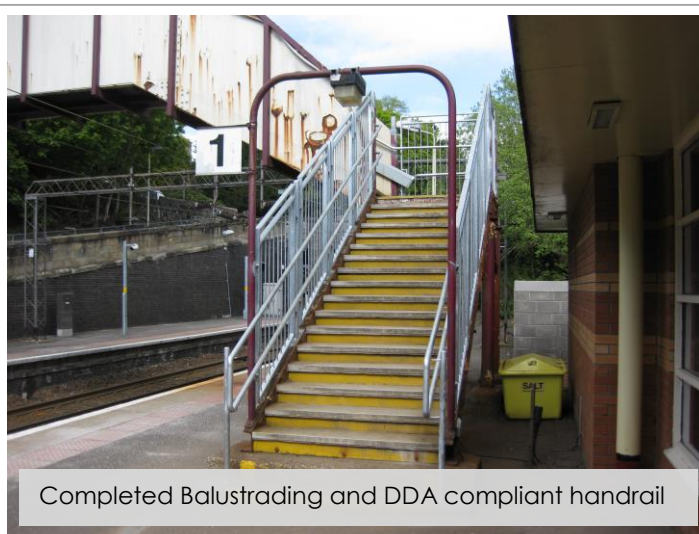
Completed Balustrading and DDA compliant handrail
